Hartford and New Haven Railroad, Depot
35 Central Street
Windsor
Hartford County
Connecticut

HAER No. CT-23-A

HISTORIC AMERICAN ENGINEERING RECORD

Hartford and New Haven Railroad, Depot

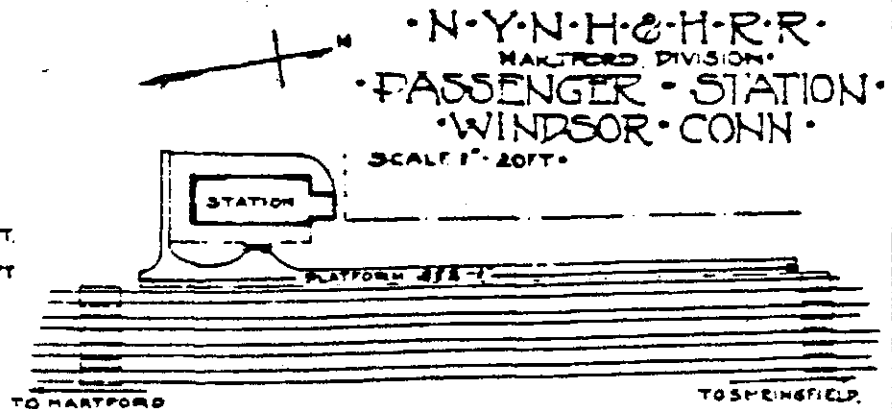
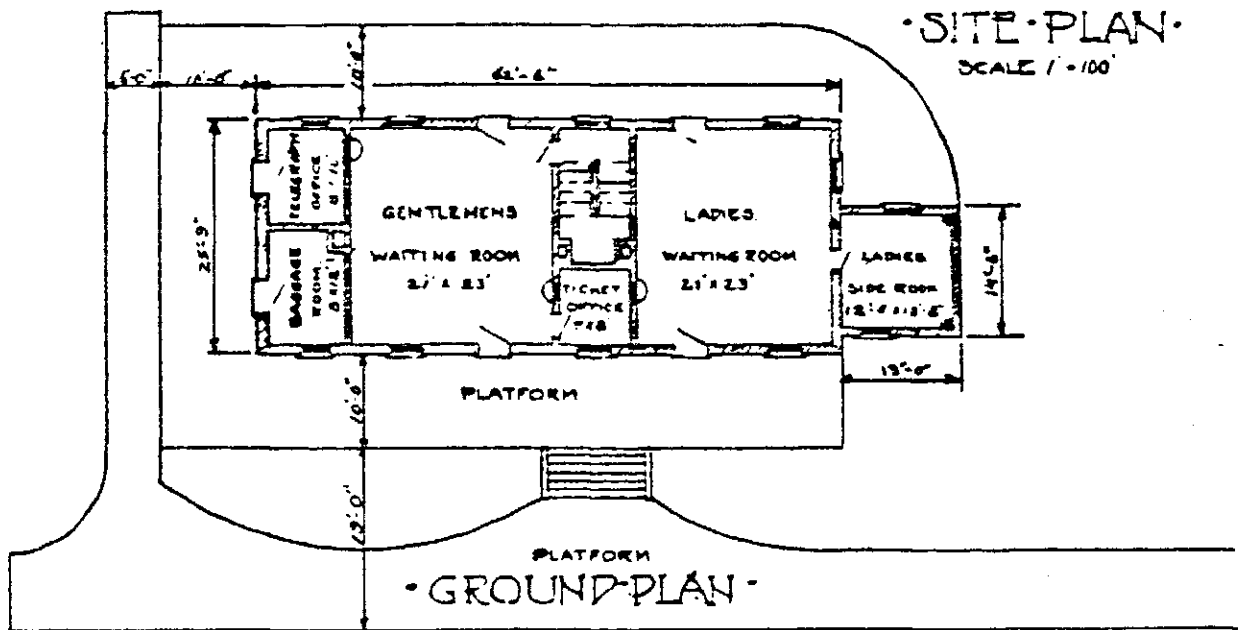
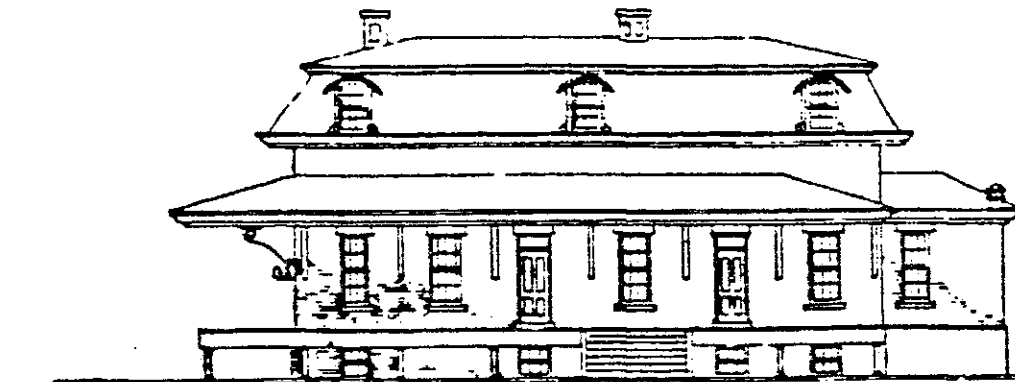
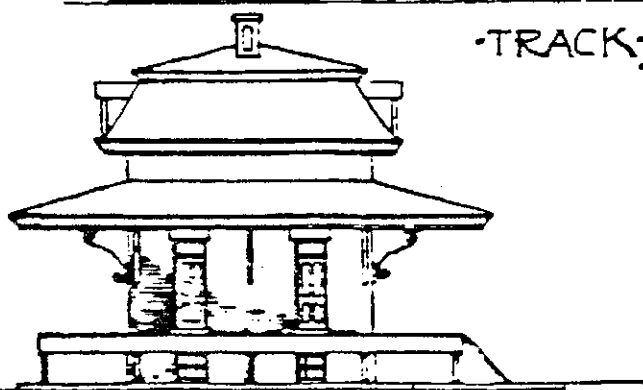
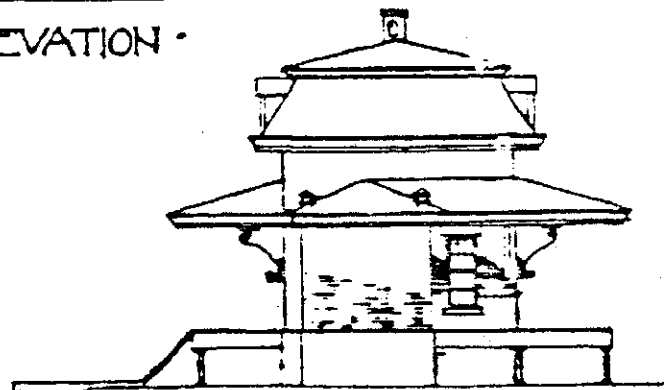
ROOF
COVER SHED NONE.
PLATFORM 6' 1382'
HEATING
LIGHTS
SEWAGE
FINISH BRICK WALLS

DATE OF CONSTRUCTION
COST DATA TOTAL
COST OF BUILDING
AREA 1732 39 FT.
COST PER SQ FT
CUBICAL CONTENTS 53240 CU FT
COST PER CU FT
COST OF PLATFORM
COST OF COVER SHED.
CONTRACTOR

4. Builder, contractor, supplier: Not known.
5. Original plans and construction: Original plans have not been located. However, a floor plan and elevation which were drawn in 1915 appear to have been done for the owner, the New York, New Haven, and Hartford Railroad, as part of a document. A copy is on page 10.

Included in this document is a drawing dated November 26, 1915, which has the ground floor plan as well as south, east, and north elevations (page 10).

- 2. Historic landscape design: There is no planned landscaping around the building. The floor plan on page 10, which was drawn in 1915, shows the placement of sidewalks at that point.

- A. Architectural drawing: Original drawings have not been located. There is a drawing from 1915 (included on page 10) which shows the main floor plan and elevation. The current alteration plans, prepared in 1985, are on file at the Windsor Town Hall.
